Make: TOYOTA Model: PREVIA Vehicle Registration: SSCARY
 Name of Station: VTNZ Sylvia Park Inspection Date: 07 Oct 2011 PPI Report No: PPI000124

INSPECTION RESULTS – ITEMS FOR YOUR CONSIDERATION

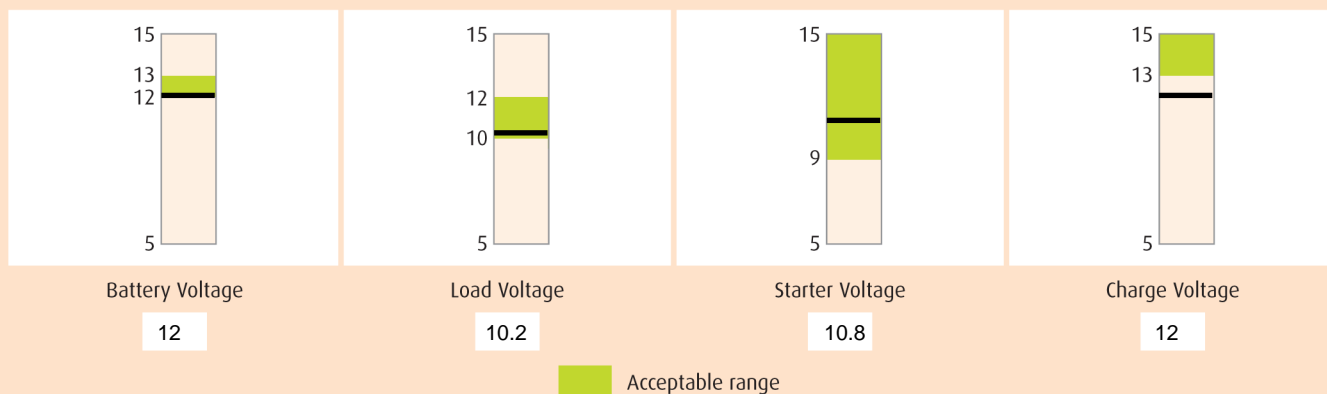
Electrical

Battery Condition: GOOD FOR AGE
Charging System: Faulty;
 VERY WEAK UNDER LOAD
Starter System: GOOD FOR AGE
